September 1945 as  
Memorandum Report E5I27a

**EFFECT OF MAXIMUM CRUISE-POWER OPERATION AT ULTRA-LEAN  
MIXTURE AND INCREASED SPARK ADVANCE ON THE MECHANICAL  
CONDITION OF CYLINDER COMPONENTS**

By Herbert B. Harris, Robert T. Duffy, and Robert D. Erwin, Jr.

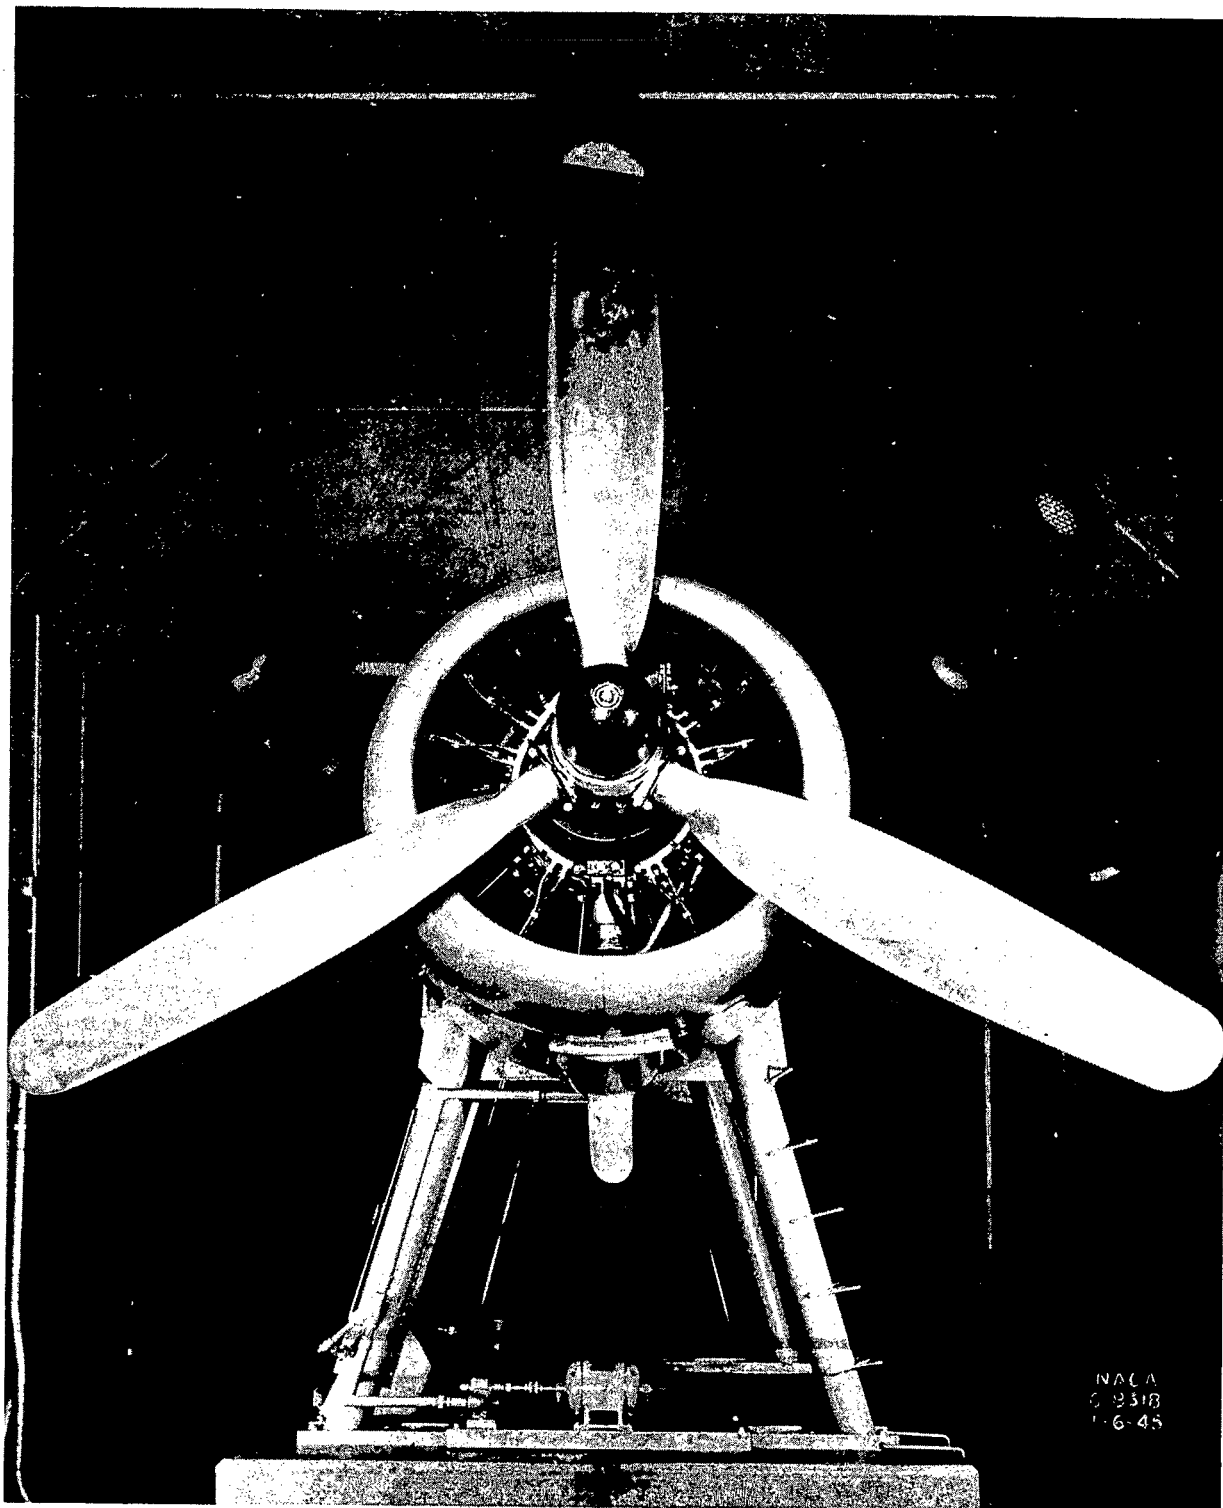
Figure 1. - Nine-cylinder air-cooled radial engine test setup for continuous 50-hour multicylinder-engine test.

The engine was mounted on a multicylinder-engine test stand as shown in figure 1. The power was absorbed by a three-blade flight propeller and engine speed was controlled by a hydromatic constant-speed governor. Brake mean effective pressure was indicated by a hydraulic torquemeter, which was integral with the propeller reduction gearing. Combustion air was supplied by an external blower with an aircraft filter element on its intake. The combustion-air flow was measured by the method described in reference 6 (uncompensated metering-suction differential). The carburetor with the inlet elbow

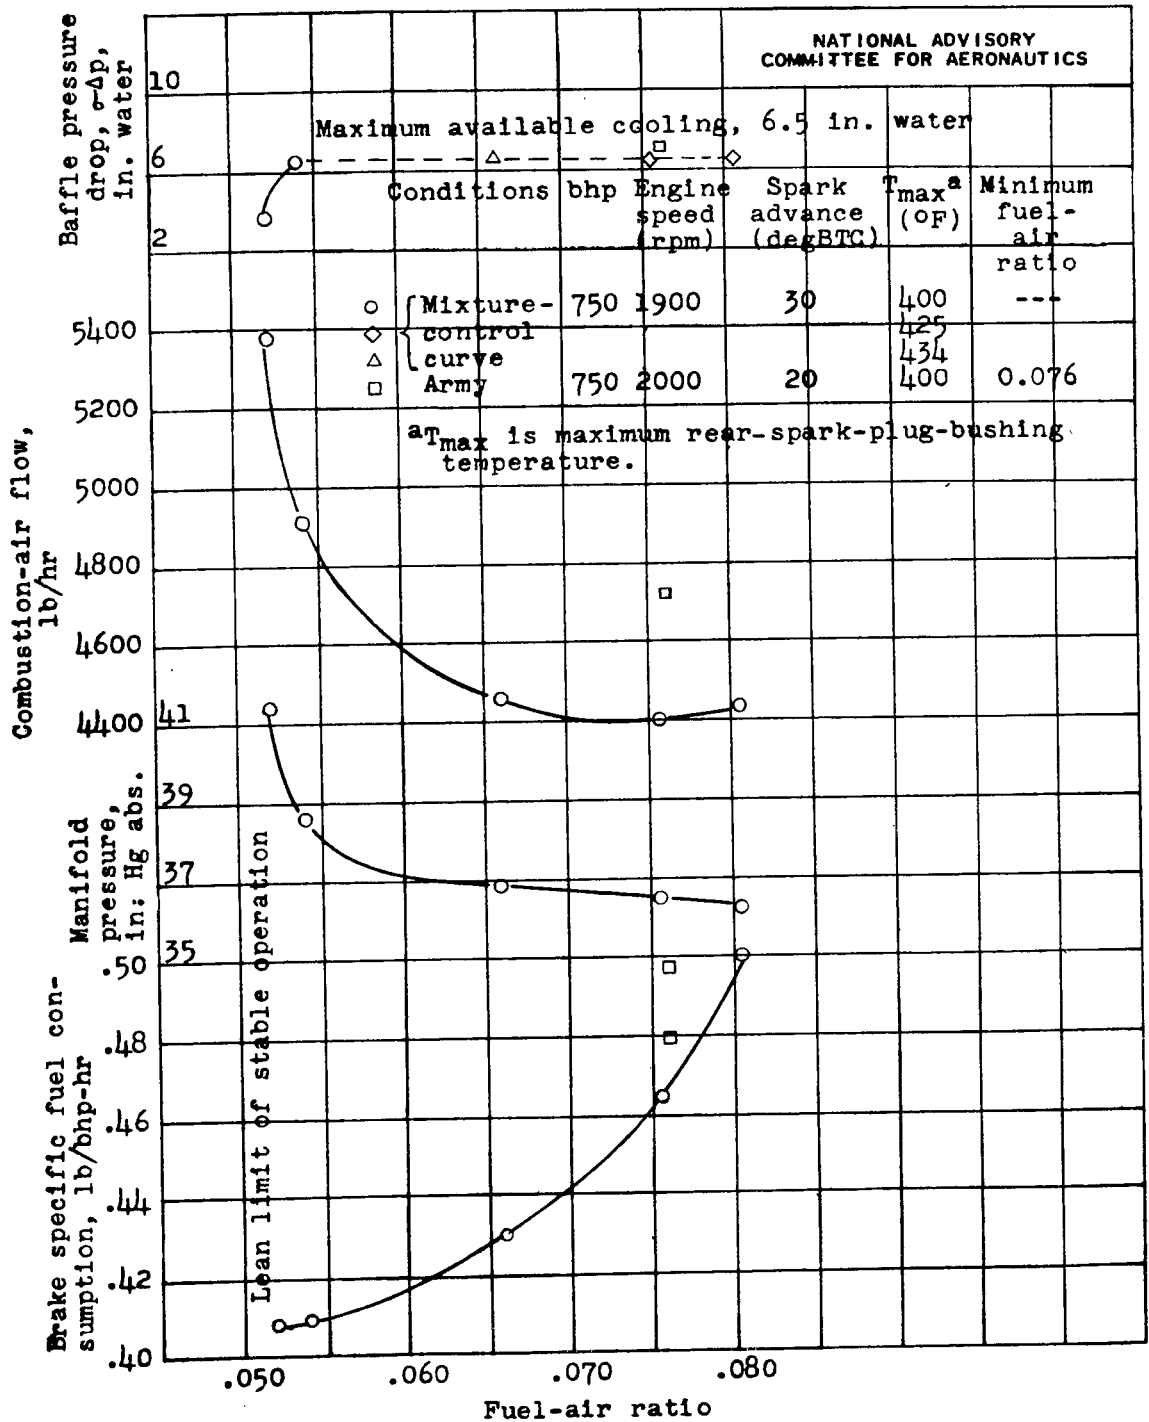
Figure 2. - Mixture-control curve for nine-cylinder air-cooled radial engine tested. Values added for the same engine operating at the conditions recommended in reference 1.

Mixture-control curve. - The optimum fuel-air ratio for the power, the speed, and the spark advance chosen was determined by the constant-power mixture-control curve (fig. 2), which was run as the first part of this test. This curve shows decreasing brake specific fuel consumption up to the lean limit for stable engine operation, fuel-air ratio of 0.052, for these conditions. The brake specific fuel consumption for this engine operating at 750 brake horsepower

at the conditions recommended in reference 1 was determined and is plotted on figure 2 for comparison. The difference between the specific fuel consumption (at the conditions of reference 1) and that for the conditions of this test indicates a fuel saving of 14.6 percent for the same power output neglecting the difference in cooling-air drag horsepower between the two conditions. The saving taking into account the difference in cooling-air drag horsepower (cooled-power basis) was calculated according to the method of reference 2 and found to be 16.8 percent.

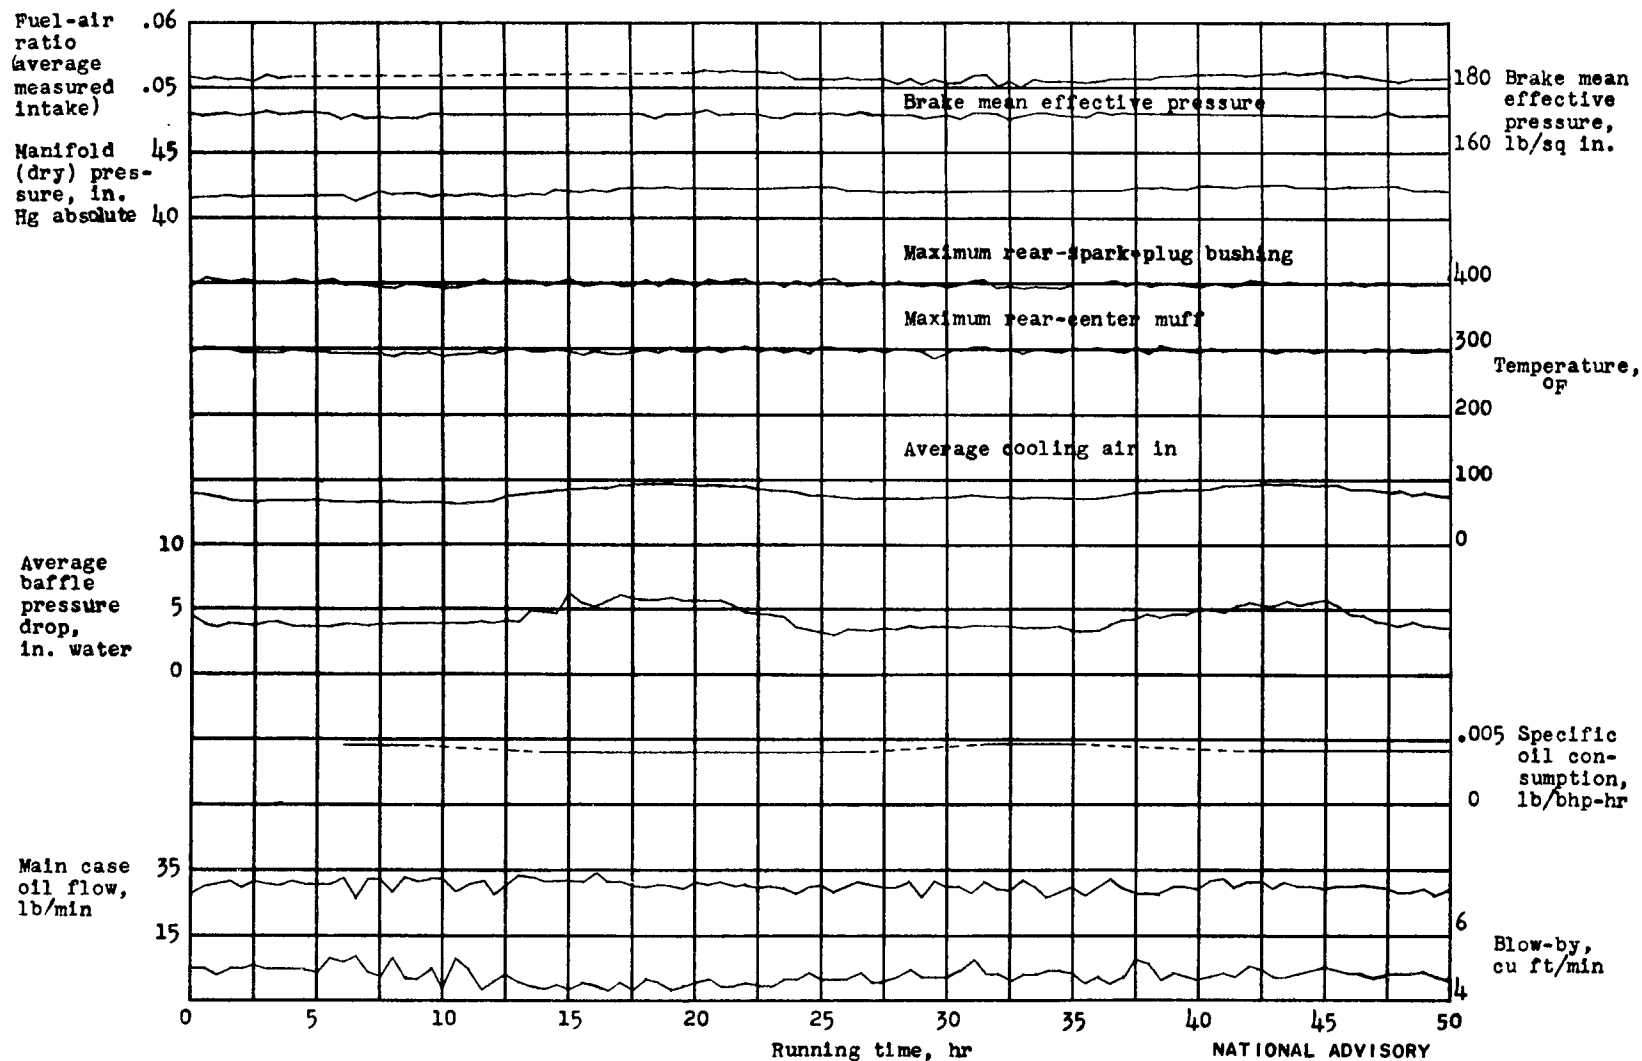
Figure 4. - Graphic log of 50-hour test of nine-cylinder air-cooled radial engine. Brake horsepower, 750; engine speed, 1900 rpm; brake mean effective pressure, 172 pounds per square inch; fuel-air ratio, 0.052; spark advance, 30° B.T.C.

Graphic log of test. - A graphic log of the test, which was run continuously to avoid the corrosion caused by shutdown and the excessive wear of starting, is shown in figure 4. During the entire test, the fuel-air ratio as determined by measured intake was closely checked by Orsat analysis of the oxidized exhaust gas. Because of a defective manometer line, the values of combustion-air flow and consequently fuel-air ratio by measured intake were faulty for the period of 4 to 20 hours of the test. Orsat analysis, however, showed that the maximum variation in fuel-air ratio for this period was

within the limits of variation for the entire test. Therefore this portion of the fuel-air-ratio curve is indicated as a straight dashed line on the graphic log. Specific oil consumption showed no tendency to rise during the test and was well below the manufacturer's maximum allowable specific oil consumption of 0.020 pound per brake horsepower hour for 1900 rpm cruise operation (reference 8). Blow-by also showed no tendency to rise during the test. No indication of knock was ever present.

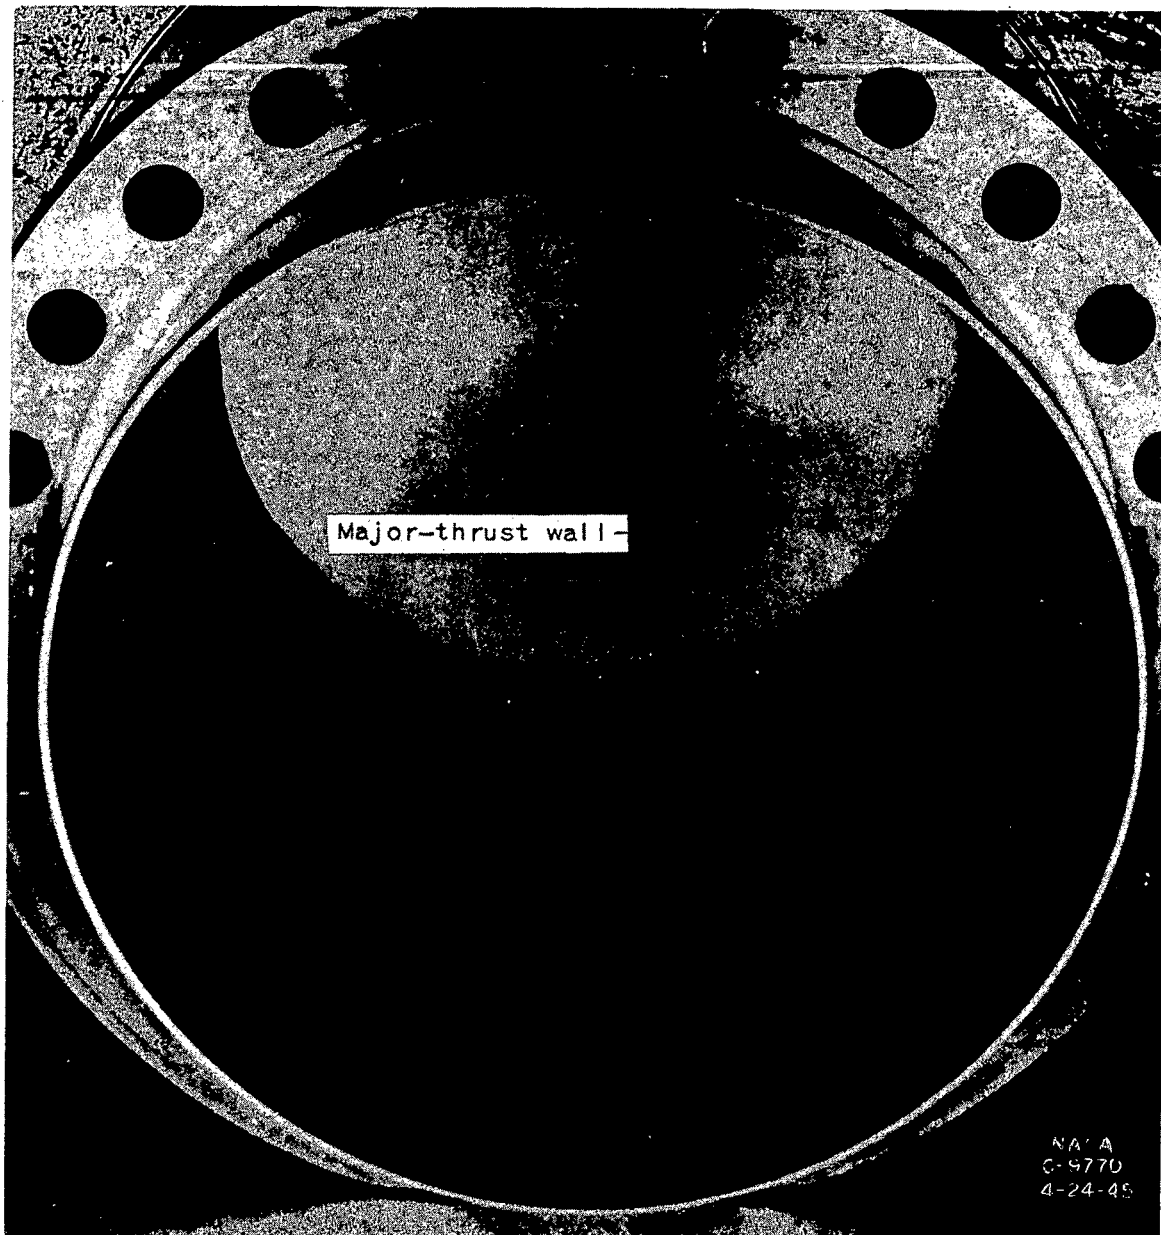
Figure 5. - Condition of bore of typical cylinder after 50-hour test of nine-cylinder air-cooled radial engine. Brake horsepower, 750; engine speed, 1900 rpm; brake mean effective pressure, 172 pounds per square inch; fuel-air ratio, 0.052; spark advance,  $30^{\circ}$  B.T.C.; maximum rear-spark-plug-bushing temperature,  $400^{\circ}$  F.

Cylinders. - Inspection of the cylinder components after engine disassembly indicated that they were in good condition. The cylinder barrels were in good condition. All the barrels were lightly lacquered and had a few light scuff marks on the major-thrust wall. The major-thrust wall of a typical cylinder barrel is shown in figure 5. The cylinder-bore wear in both the thrust and nonthrust directions resulting from the test is shown in table I. Cylinder wear, which was heaviest in the choke, was very light on the thrust and nonthrust diameters. The valve seats were in good condition. The cylinder domes had a light carbon coating with a few localized heavy-lead deposits (fig. 6). In the cylinder photographed, the localized-lead deposits were near the junction of the head and barrel between the front spark-plug bushing and the intake-valve seat insert. The localized-lead deposits in the rest of the cylinders were heavier and occurred near the junction of the head and barrel but in different places around the cylinder.

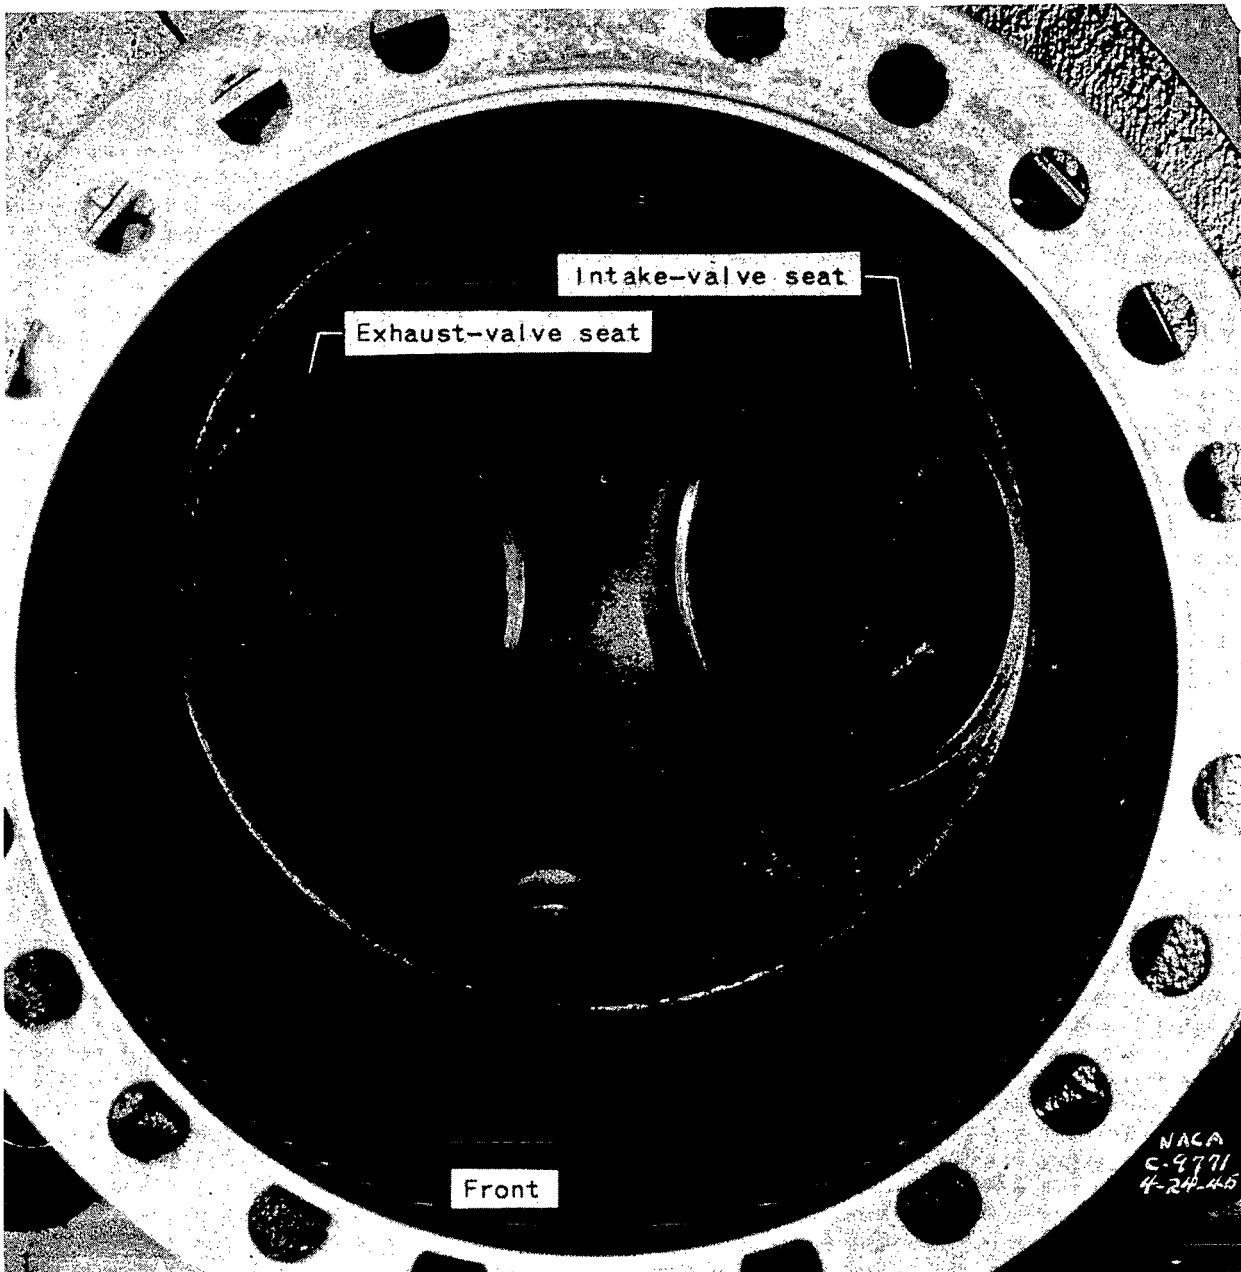
Figure 6. - Condition of combustion chamber of typical cylinder after 50-hour test of nine-cylinder air-cooled radial engine. Brake horsepower, 750; engine speed, 1900 rpm; brake mean effective pressure, 172 pounds per square inch; fuel-air ratio, 0.052; spark advance, 30° B.T.C.; maximum rear-spark-plug-bushing temperature, 400° F.

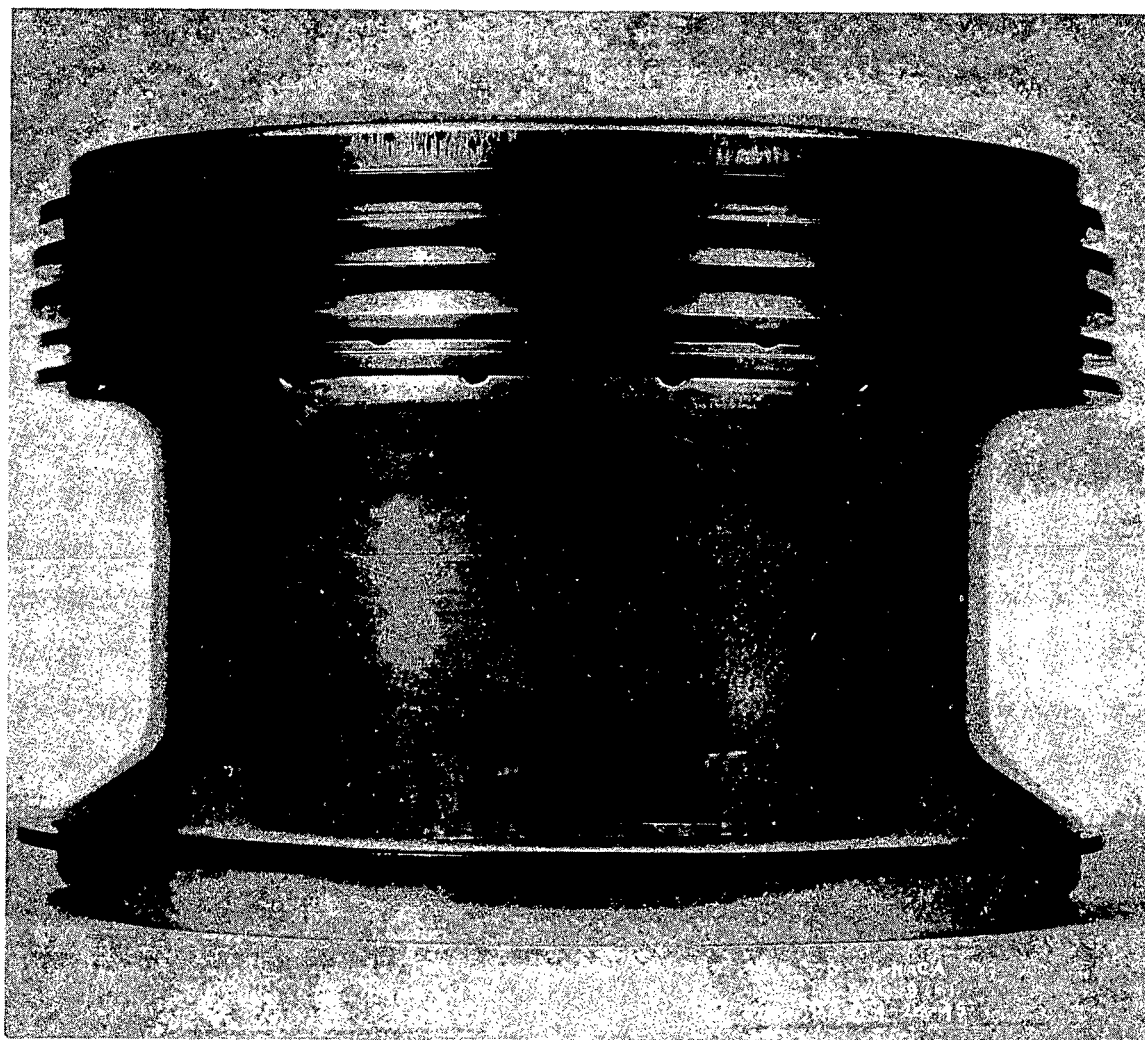
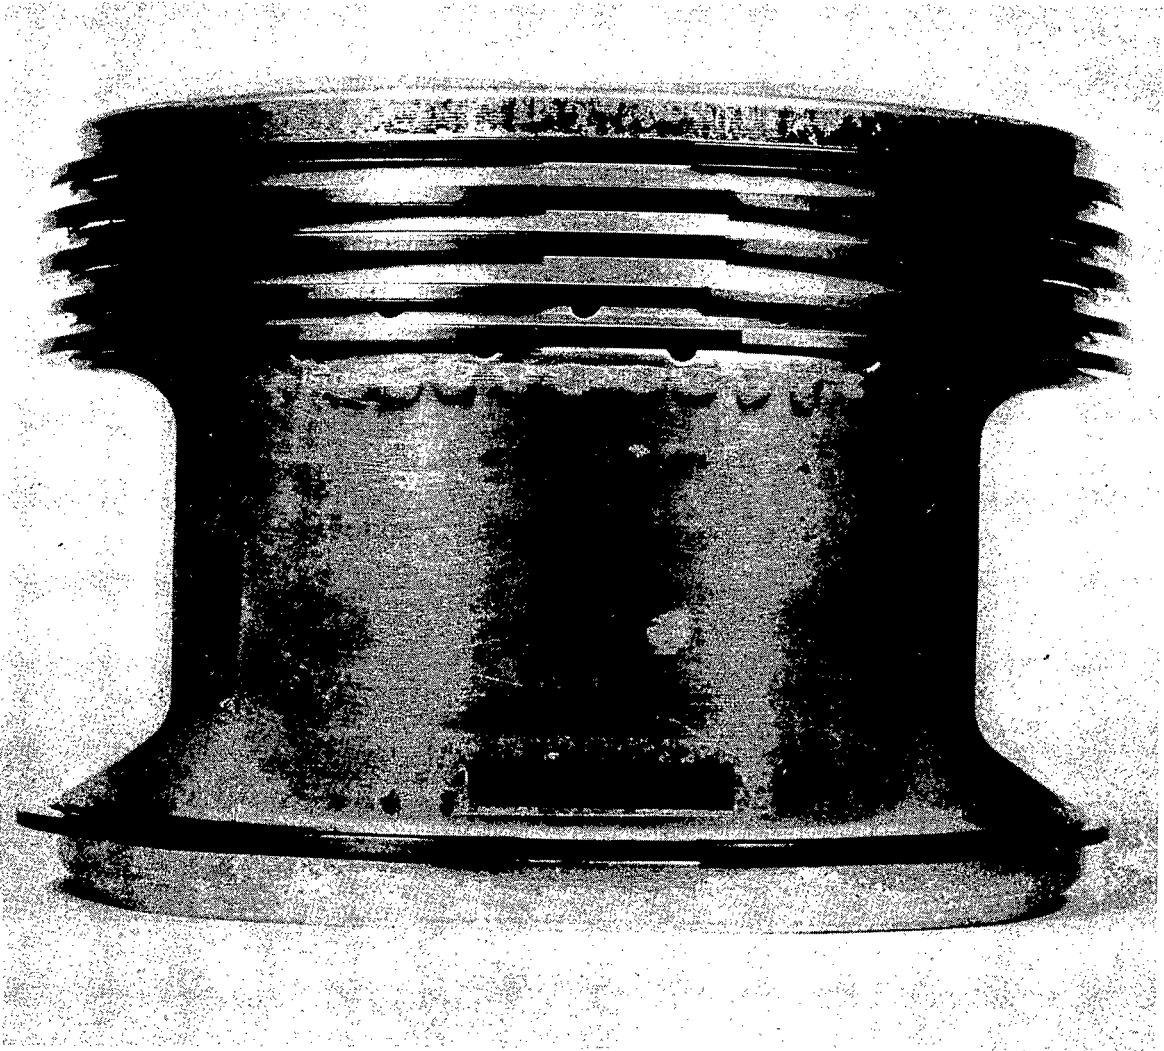
(a) Major thrust.

Figure 7. - Condition of typical piston and rings after cleaning following 50-hour test of nine-cylinder air-cooled radial engine. Brake horsepower, 750; engine speed, 1900 rpm; brake mean effective pressure, 172 pounds per square inch; fuel-air ratio, 0.052; spark advance,  $30^{\circ}$  B.T.C.; maximum rear-spark-plug-bushing temperature,  $400^{\circ}$  F.

(b) Minor thrust.

Pistons and piston rings. - The pistons were in very good condition at the end of the test. The piston crowns were covered with a light carbon deposit and small localized-lead deposits similar to those on the dome of the cylinders. The major-thrust and minor-thrust faces of a typical piston with rings after cleaning at the end of the test are shown in figure 7. These photographs show the light face contact at the top and bottom of the thrust faces and the light scuff marks on the piston thrust face. Piston wear resulting from the test was too small to measure. No pounding out of the ring lands existed as shown by the values of piston-ring side clearance in table II.

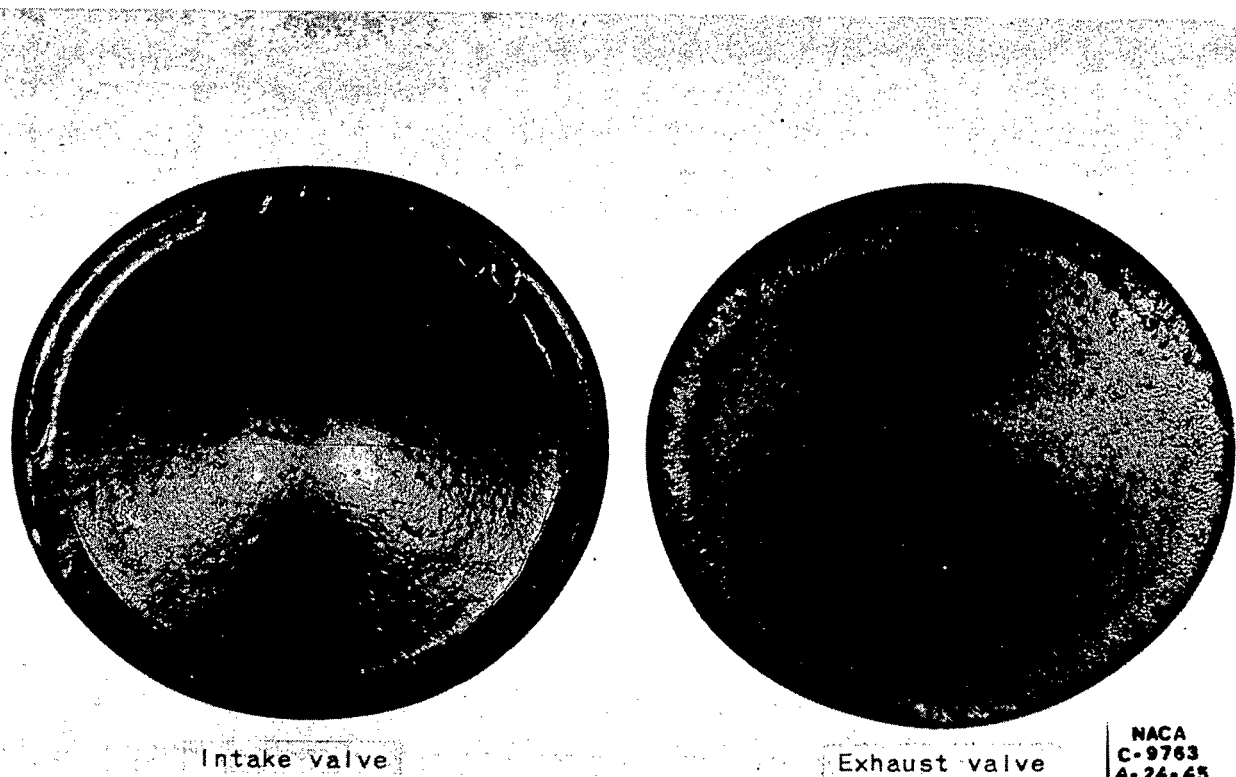
Figure 8. - Valve heads of cylinder 7 typical of intake and exhaust valves after 50-hour test of nine-cylinder air-cooled radial engine. Brake horsepower, 750; engine speed, 1900 rpm; brake mean effective pressure, 172 pounds per square inch; fuel-air ratio, 0.052; spark advance;  $30^{\circ}$  B.T.C.; maximum rear-spark-plug-bushing temperature,  $400^{\circ}$  F.

Valves. - All the valve heads were covered with a heavy deposit when they were removed from the engine. The typical heavy deposits on the heads of both the intake and exhaust valves are shown in figure 8. The deposits on the intake valves were greenish-yellow with a

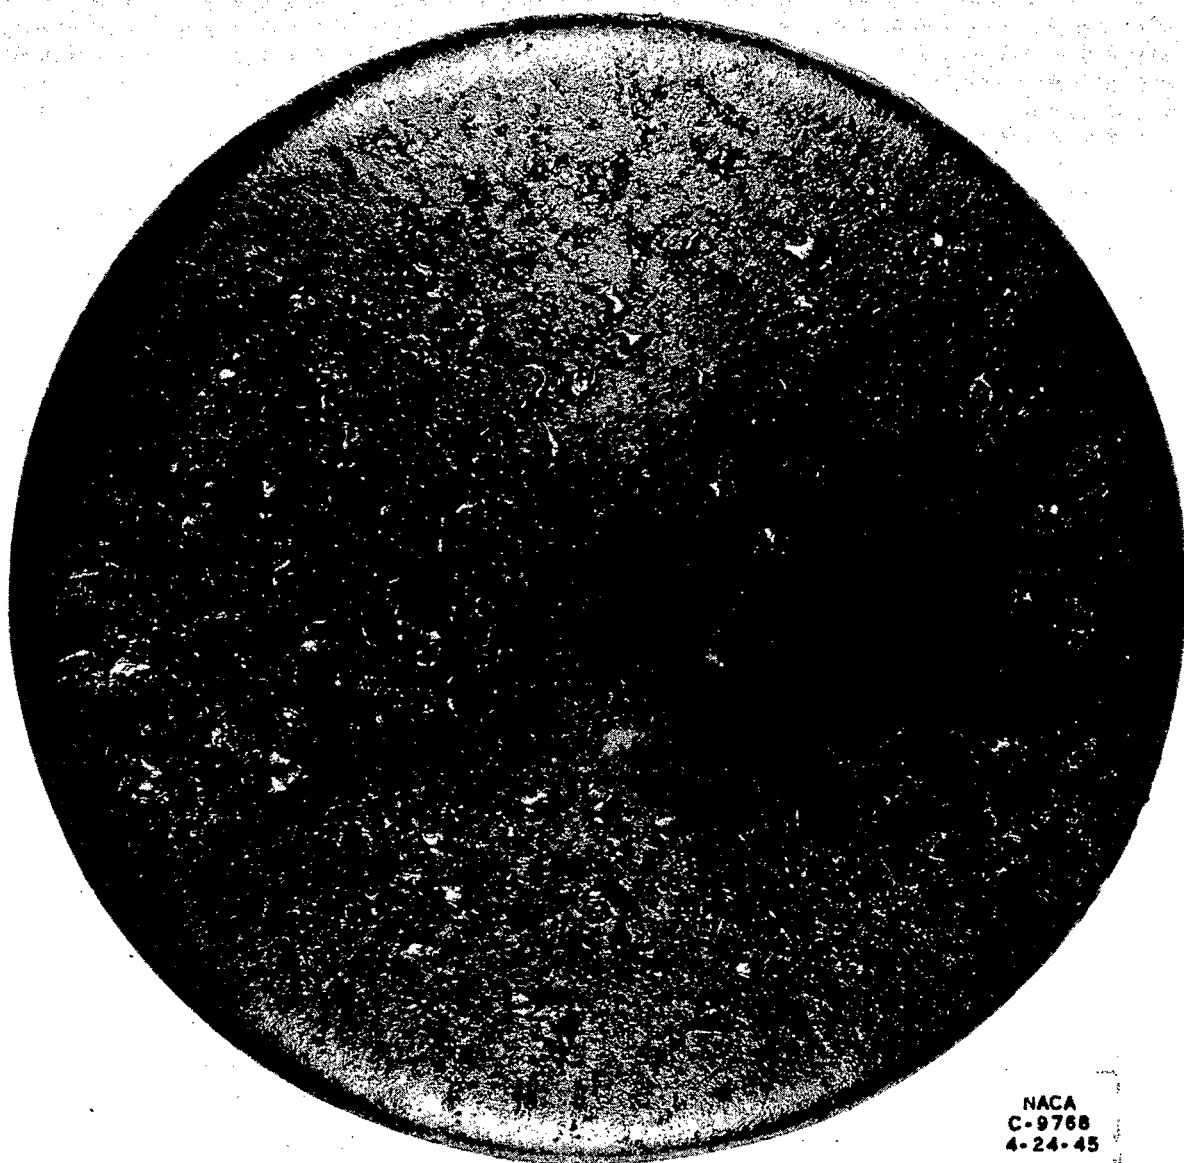
Figure 9. - Condition of exhaust-valve head from cylinder 9 after 50-hour test in nine-cylinder air-cooled radial engine. Brake horsepower, 750; engine speed, 1900 rpm; brake mean effective pressure, 172 pounds per square inch; fuel-air ratio, 0.052; spark advance, 30° B.T.C.; maximum rear-spark-plug-bushing temperature, 400° F.

glazed surface and completely covered the concave portion of the valve head. The coating on the exhaust valves varied from the smooth greenish-yellow deposits shown on the valve in figure 8 to the dark red globular deposits shown on the valve head in figure 9. The weight of the deposits on the valves is given in table III. The average weight of deposit was 4.15 and 7.26 grams for the exhaust and intake valves, respectively.

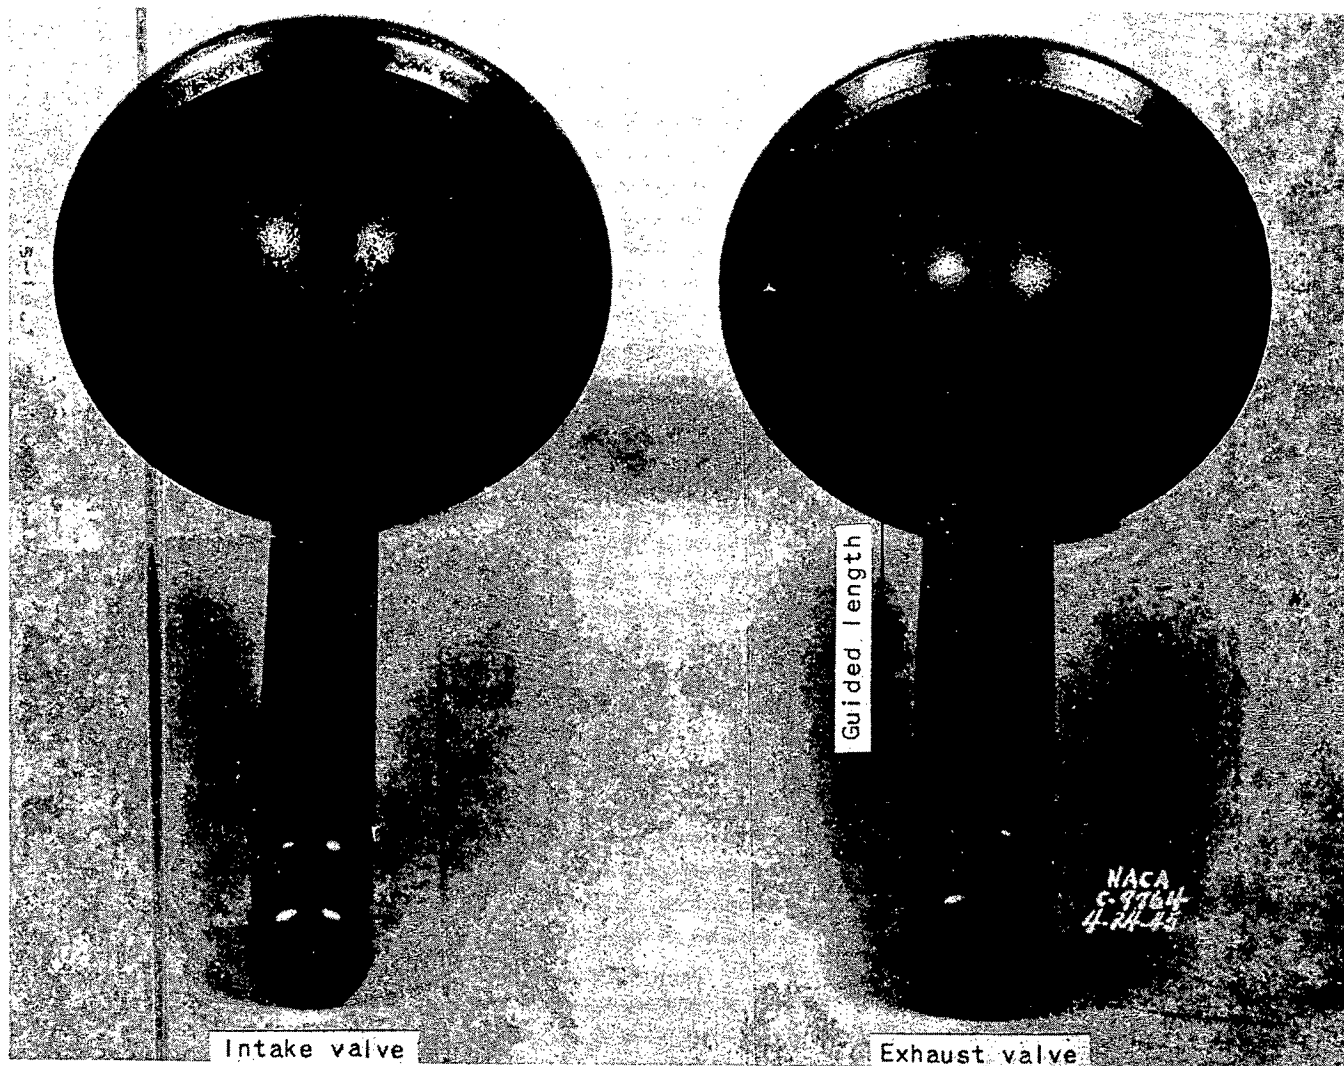
Figure 10. - Condition of valve stems and necks from cylinder 7 typical of intake and exhaust valves after 50-hour test in nine-cylinder air-cooled radial engine. Brake horsepower, 750; engine speed, 1900 rpm; brake mean effective pressure, 172 pounds per square inch; fuel-air ratio, 0.052; spark advance,  $30^{\circ}$  B.T.C.; maximum rear-spark-plug-bushing temperature,  $400^{\circ}$  F.

The stems and seating faces of a typical intake and exhaust valve after removal from the engine are shown in figure 10. An examination of the valves after cleaning showed that all of the exhaust-valve faces were in good condition with the exception of the valve from cylinder 9, which was lightly burned in one spot. The burn was very shallow and before cleaning was filled with a hard deposit so that the valve face formed an unbroken seal and the mating seat showed no evidence of burning. It is therefore improbable that the light valve-face burning would progress further. The lightly burned portion of the exhaust-valve face of cylinder 9 after the deposits had been removed is shown in figure 11.

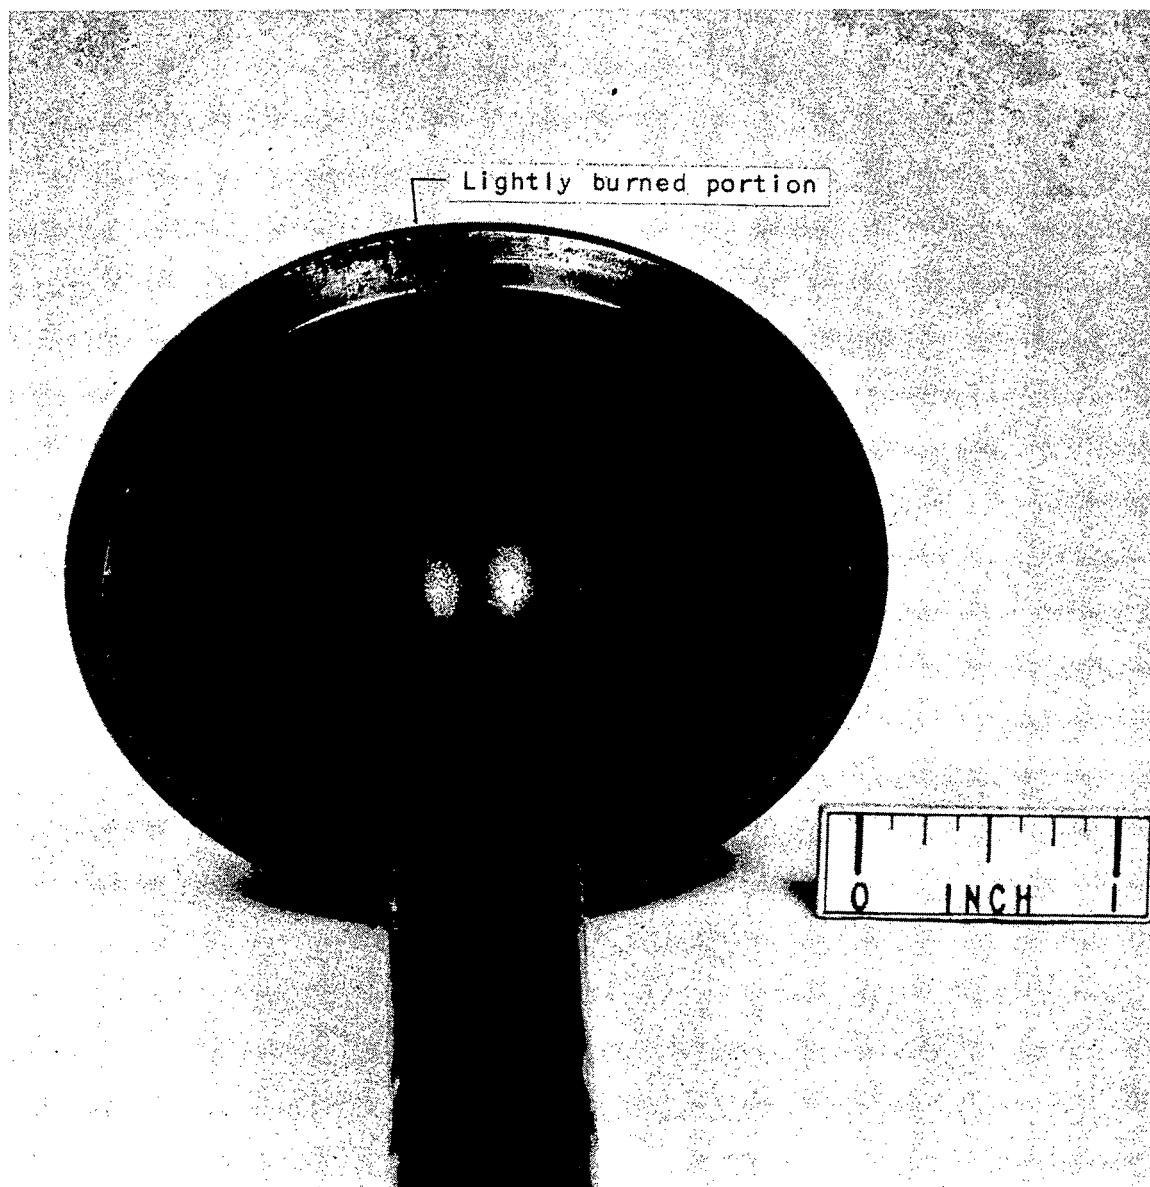
Figure 11. - Condition of exhaust-valve face from cylinder 9 after 50-hour test in nine-cylinder air-cooled radial engine. Brake horsepower, 750; engine speed, 1900 rpm; brake mean effective pressure, 172 pounds per square inch; fuel-air ratio, 0.052; spark advance, 30° B.T.C.; maximum rear-spark-plug-bushing temperature, 400° F.

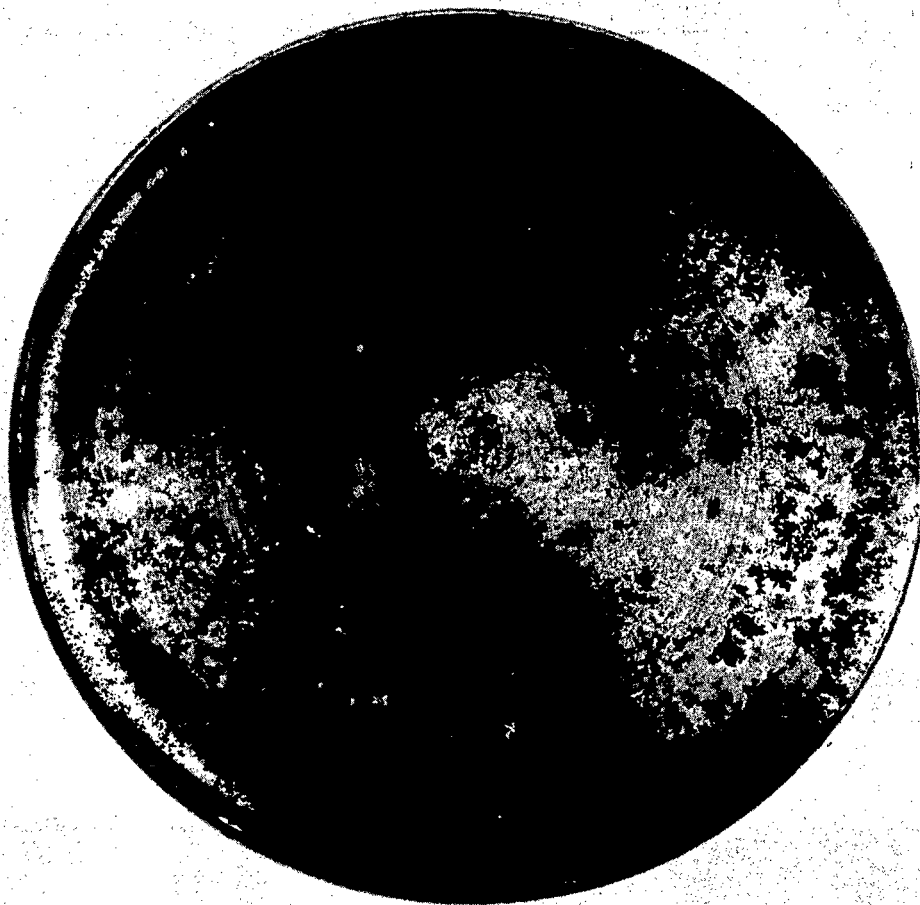
Figure 12. - Condition of exhaust-valve crown from cylinder 9 after cleaning following 50-hour test in nine-cylinder air-cooled radial engine. Brake horsepower, 750; engine speed, 1900 rpm; brake mean effective pressure, 172 pounds per square inch; fuel-air ratio, 0.052; spark advance, 30° B.T.C.; maximum rear-spark-plug-bushing temperature, 400° F.

All of the valves, except two sets, were cleaned by the electrolytic method of reference 12. The deposits were not removed from these two sets of valves pending further investigation of the deposits. Of the valves cleaned, the crowns of two were in excellent condition, four had numerous "pin-point" pit marks, and one was severely pitted as shown in figure 12. Some of the intake valves had a few very small scattered pin-point pits. (See table III.)

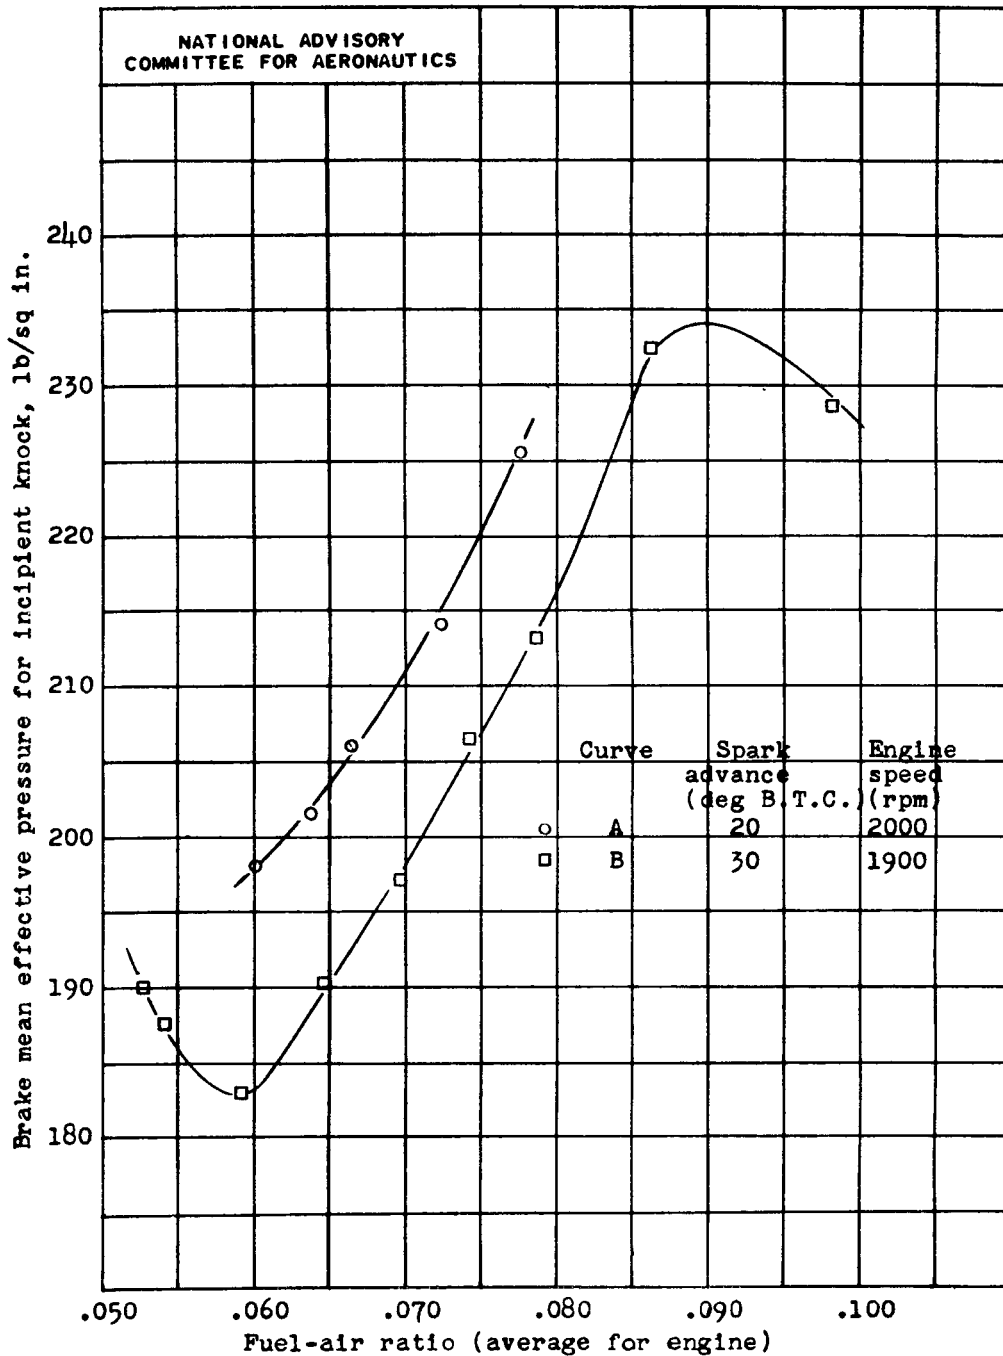
Figure 13. - Maximum brake mean effective pressure as limited by incipient knock, for two conditions of speed and spark advance obtained from tests of nine-cylinder air-cooled radial engine. Carburetor-air temperature, 100° F; maximum rear-spark-plug-bushing temperature, 500° F; fuel, AN-F-28, Amendment-2.

For this engine, the maximum brake mean effective pressure as limited by incipient knock was approximately 15 percent lower for the conditions of this test (fuel-air ratio, 0.052; spark advance, 30° B.T.C.; and engine speed, 1900 rpm) than for those recommended by the Army (fuel-air ratio, 0.076; spark advance, 20° B.T.C.; and engine speed, 2000 rpm). (See fig. 13.)

As shown in figure 13, the knock-limited brake mean effective pressure at a fuel-air ratio of 0.052, spark advance of 30° B.T.C., and engine speed of 1900 rpm, and at a maximum rear-spark-plug-bushing temperature of 500° F was 192 pounds per square inch. Therefore, operation of this engine at 750 brake horsepower at the conditions of this test should allow a margin of safety on the brake mean effective pressure for incipient knock of approximately 12 percent if the higher cylinder temperature allowed during the running of the knock curves were neglected. Although no attempt will be made to correct the margin of safety for the 100° F difference in maximum cylinder-head temperature, it should be pointed out that an increase in cylinder-head temperature will decrease the knock-limited brake mean effective pressure a considerable amount at low fuel-air

ratios (reference 14). Therefore, the actual margin of safety for incipient knock for a maximum rear-spark-plug-bushing temperature of  $400^{\circ}\text{F}$  should be considerably higher than the 12 percent indicated on figure 13.
